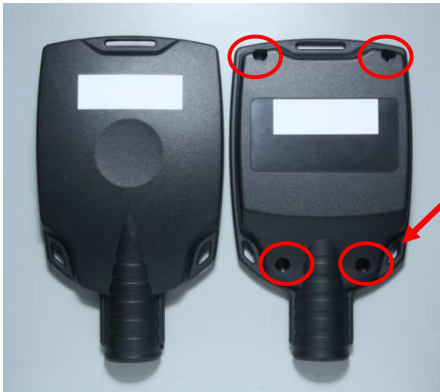
During installation/vehicle repair, the wiring harness may be pulled excessively and prevent the unit from working properly. Open GO housing to inspect internal connections. Remove the 4 Philips screws.

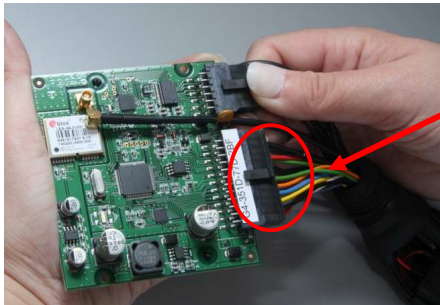
For Power related problems, verify that GO harness is connected securely to the main board. Ensure that all pins are locked into the black molex.

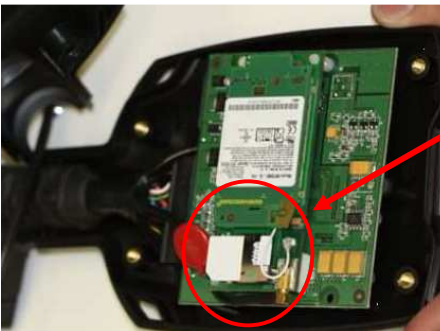
Verify that GSM board and GSM pigtail are securely connected. Verify that sim card is seated correctly.

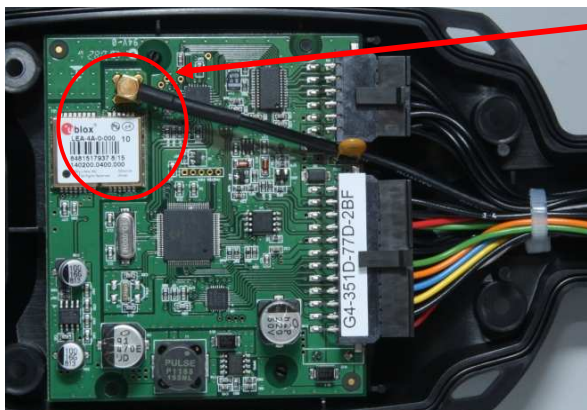
For GPS tests, verify that GPS pigtail is securely connected to the right angle connector and has no visual damage.
