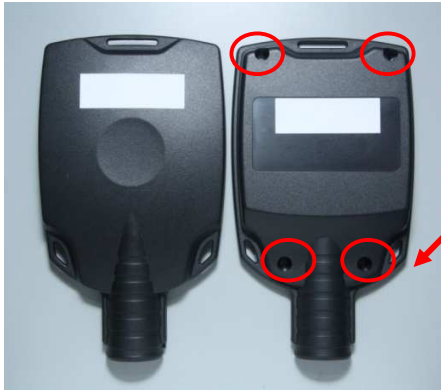
During installation/vehicle repair, the wiring harness may be pulled excessively and prevent the unit from working properly. Open GO housing to inspect internal connections. Remove the 4 Philips screws.

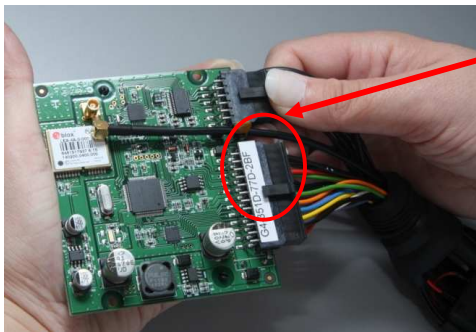
For Power related problems, verify that GO harness is connected securely to the main board. Ensure that all pins are locked into the black Molex.

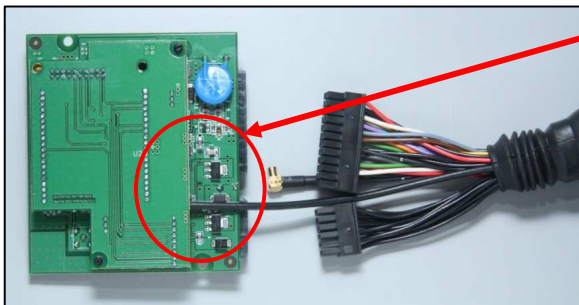
Verify that RF board and RF pigtail are securely connected.

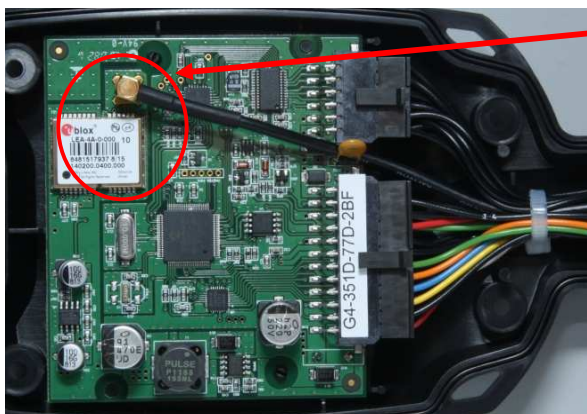
For GPS tests, verify that GPS pigtail is securely connected to the right angle connector and has no visual damage
